Prepared for
Craton Mining and Exploration (Pty) Ltd
PO Box 90128
Windhoek
Namibia

Prepared by
Knight Piésold Consulting (Pty) Ltd.
11 Nelson Mandela
Klein Windhoek
Windhoek, Namibia
PO Box 80682, Eros

RI301-00478/06

**OMITIOMIRE COPPER PROJECT: HEAP LEACH
EARTHWORKS AND FOUNDATION DESIGN, PHASE 2
GROUND WATER AND SURFACE WATER STUDIES
FEASIBILITY LEVEL GEOTECHNICAL
INVESTIGATION - FACTUAL AND
INTERPRETIVE REPORT**

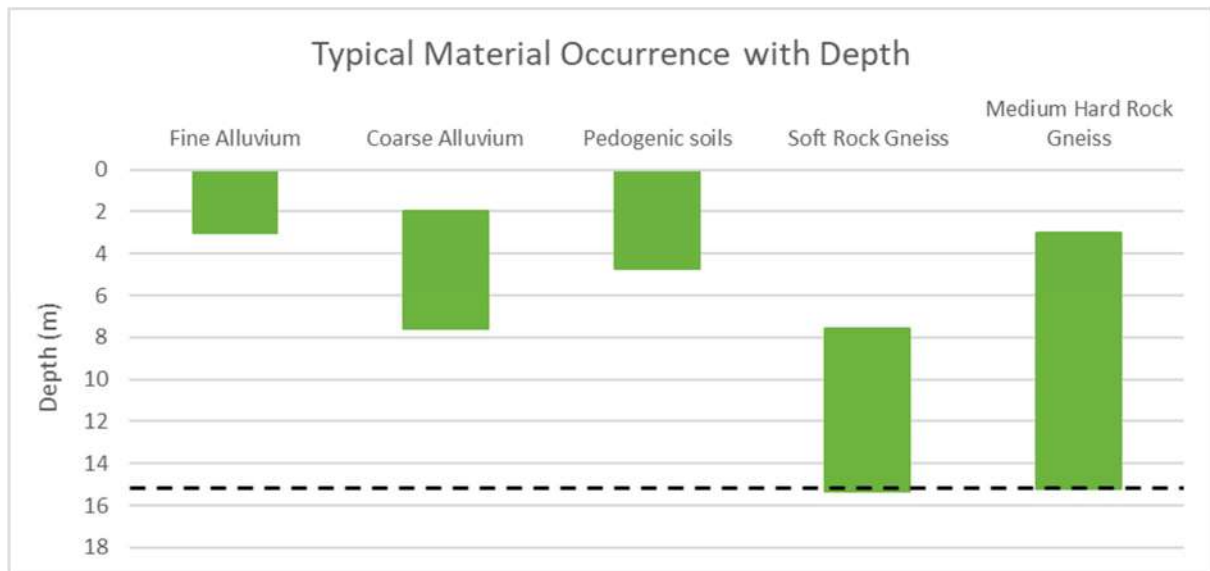
Figure 7-2: Typical Material Occurrence with Depth – SWD – Channel

The SWD channel was investigated by TP09-SWD to TP17-SWD and TP26-SWD as well as BH06-SWD and BH07-SWD. The test pits excavated through fine alluvium along the channel and generally indicate variable refusal depths in ferruginised or calcified alluvium most commonly between depths of 1.3 m and 4.4 m. The boreholes further indicate (very soft to medium hard) rock is encountered from 3 m to 7.6 m below ground level. There is no clear correlation with depth to refusal along the channel and variable conditions are anticipated along the route.

Figure 7-2 shows the potential materials at various depths based on the test pit and borehole data.

The fine alluvial soils generally grade as silty sands and classify as “SC” and “A-4” based on the USCS and AASHTO classification systems. The material has low potential expansiveness and a “Good to Fair” compaction rating.

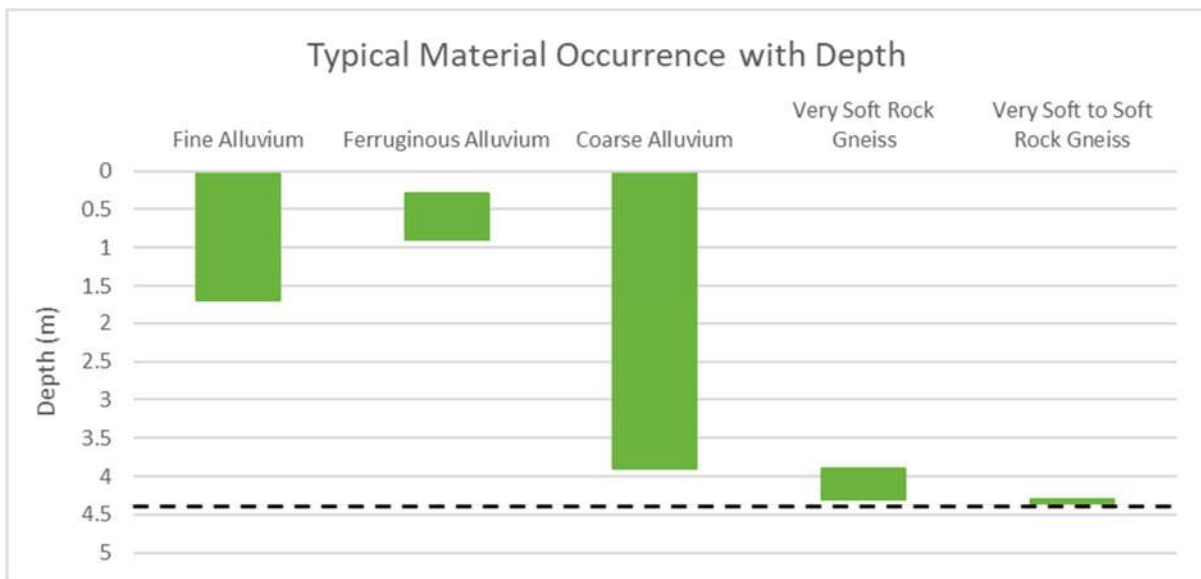
Figure 7-6: Typical Material Occurrence with Depth – Crossings 1 & 2

Laboratory results, as well as test pit data from test pits TP01-RD, TP02-RD, TP03-RD and TP16-RD were used to determine the expected foundation conditions for the structures at the river crossings at the south-western portion of the new road.

The test pits in this area refused on dense silty sand with varying gravel, alluvium to a depth of 3.9 m or in soft rock gneiss at a depth of 4.3 m in test pit TP02-RD which was dug in the middle of the river. It is expected that the rock hardness increases with depth. Figure 7-6 illustrates the typical materials encountered at various depths for this area is shown below.

Based on the test pit data, the fine alluvium and ferruginous soils comprise loose to generally dense silty sand with occasional sub-angular to subrounded gravels with a typical allowable bearing capacity of 200 kPa.

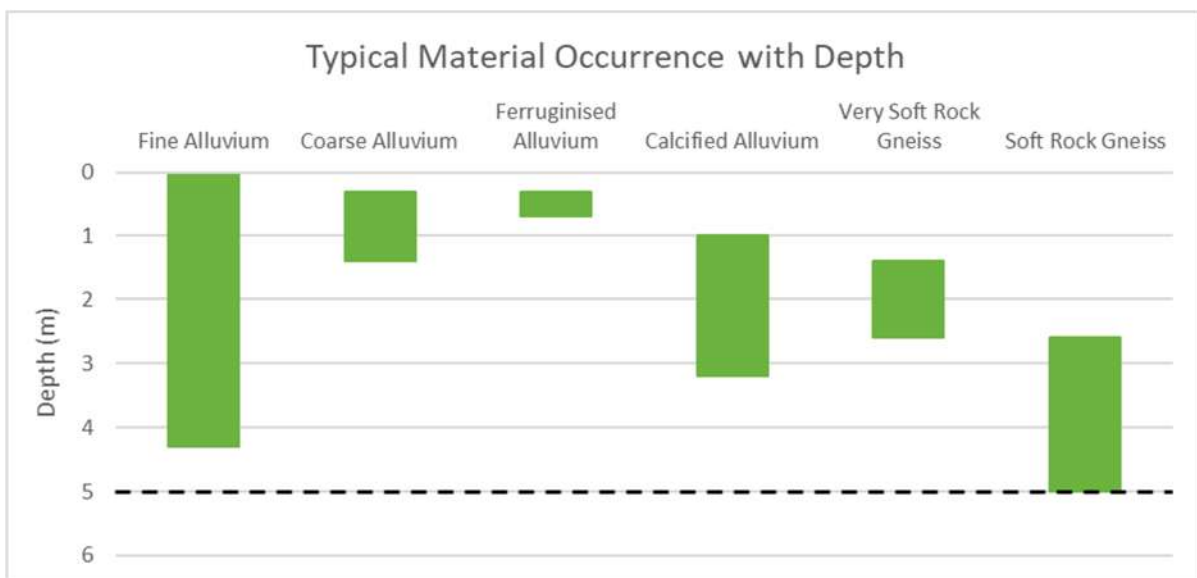
Figure 7-8: Typical Material Occurrence with Depth – Road Route

The typical soil profile between the river crossings comprises mainly medium dense to dense, with occasional loose pockets of fine alluvium from surface down a depth of 4.3 m. Coarse alluvium from 0.3 m to 1.4 m or ferruginised alluvium from 0.3 m to 0.7 m is encountered below shallow fine alluvium. Medium dense becoming dense calcified alluvium was identified in test pit TP08-RD from 1.0 m down to 3.2 m.

Very soft rock gneiss was encountered only in test pit TP14-RD from 1.4 m down to 2.6 m after which the excavator refused on soft rock gneiss. Figure 7-8 shows the materials that are typically encountered with depth across this area.

The fine and calcified alluvium grade mainly as silty or clayey sands with low gravel content in the coarse alluvial material. The fine alluvial soils comprise more than 60% sand and no gravel. The alluvium classifies as “SM” based on the USCS system; however, the fine alluvium classifies as “A-2” while the coarse alluvium classifies as “A-7” based on the AASHTO classification. The materials have a low potential expansiveness and low compressibility rating, as well as a “Good” compaction rating.

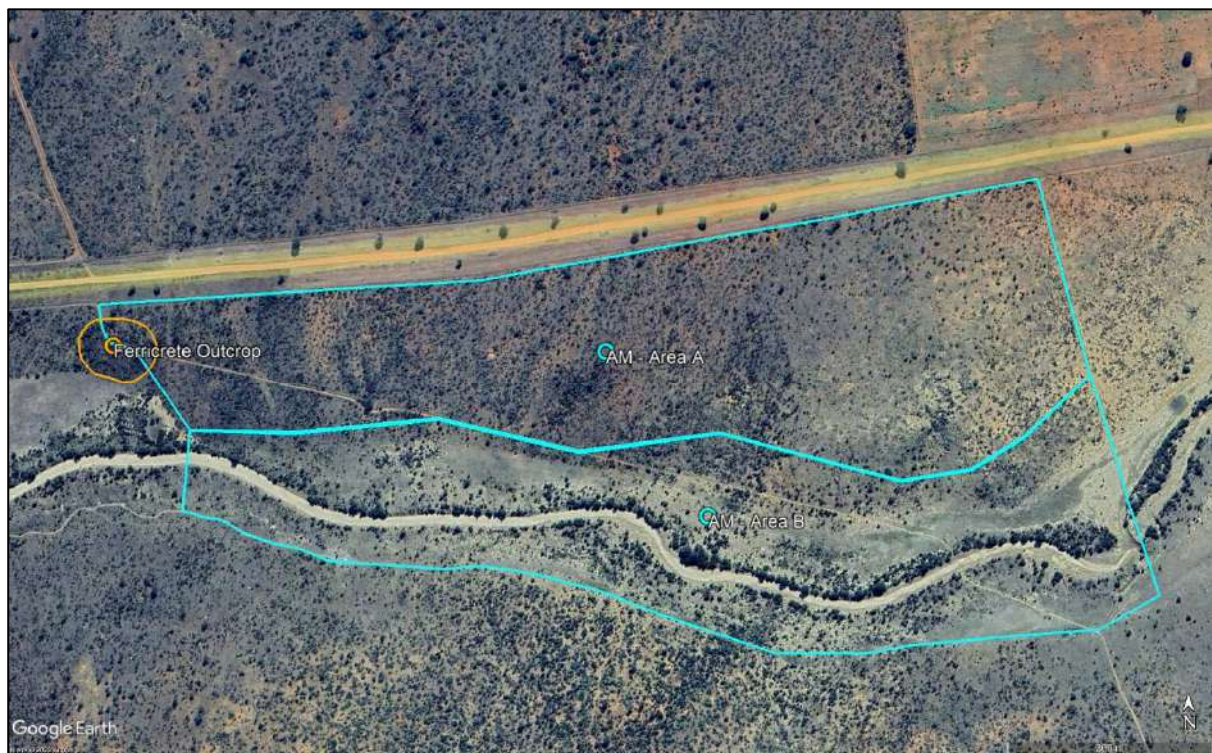
Figure 7-11: Ferricrete Outcrop at the AM site

A prominent hardpan ferricrete outcrop was identified during the field investigation along the road on the western boundary of Area A. The size of the ferricrete outcrop is estimated at 8,800 m². The occurrence of the ferricrete outcrop is highlighted in orange in Figure 7-11 below.

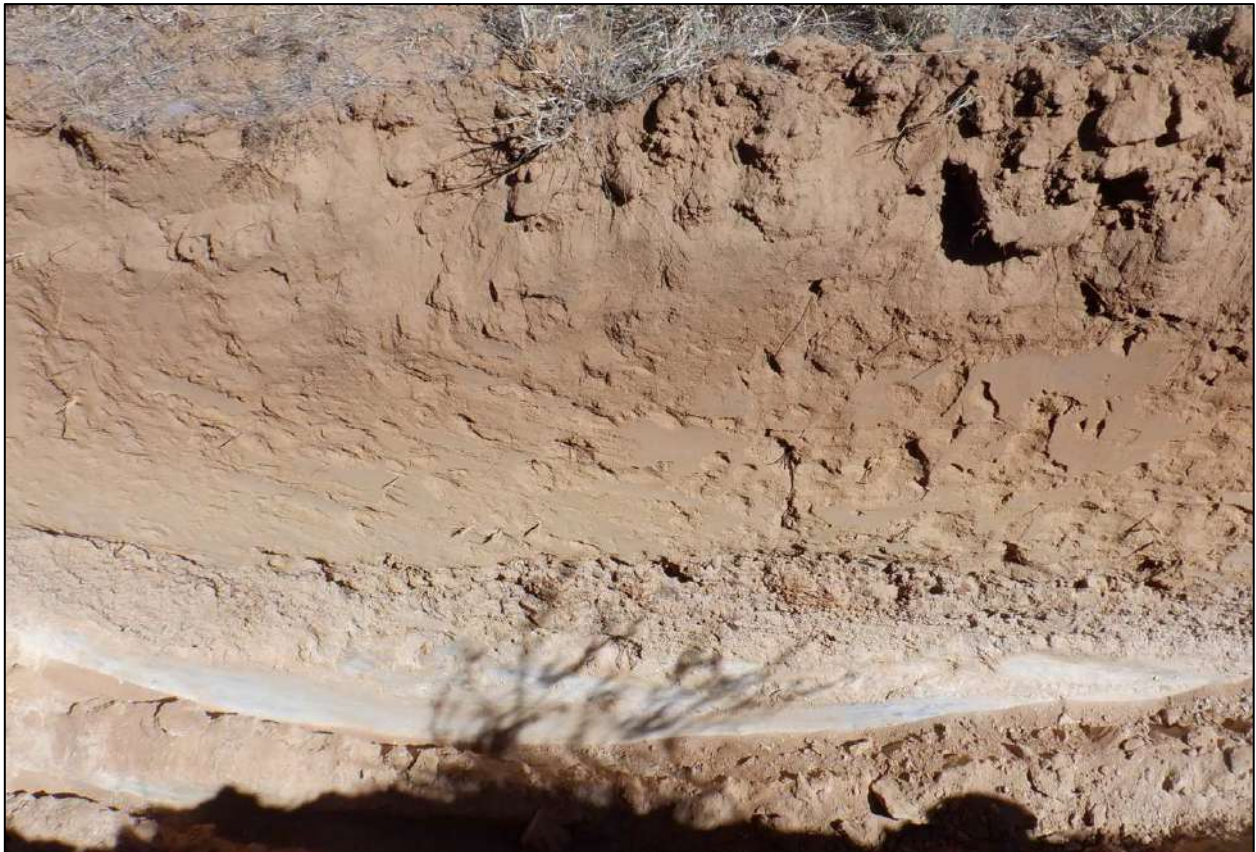
Plate 10: Typical soil profile at HLP-TP24.

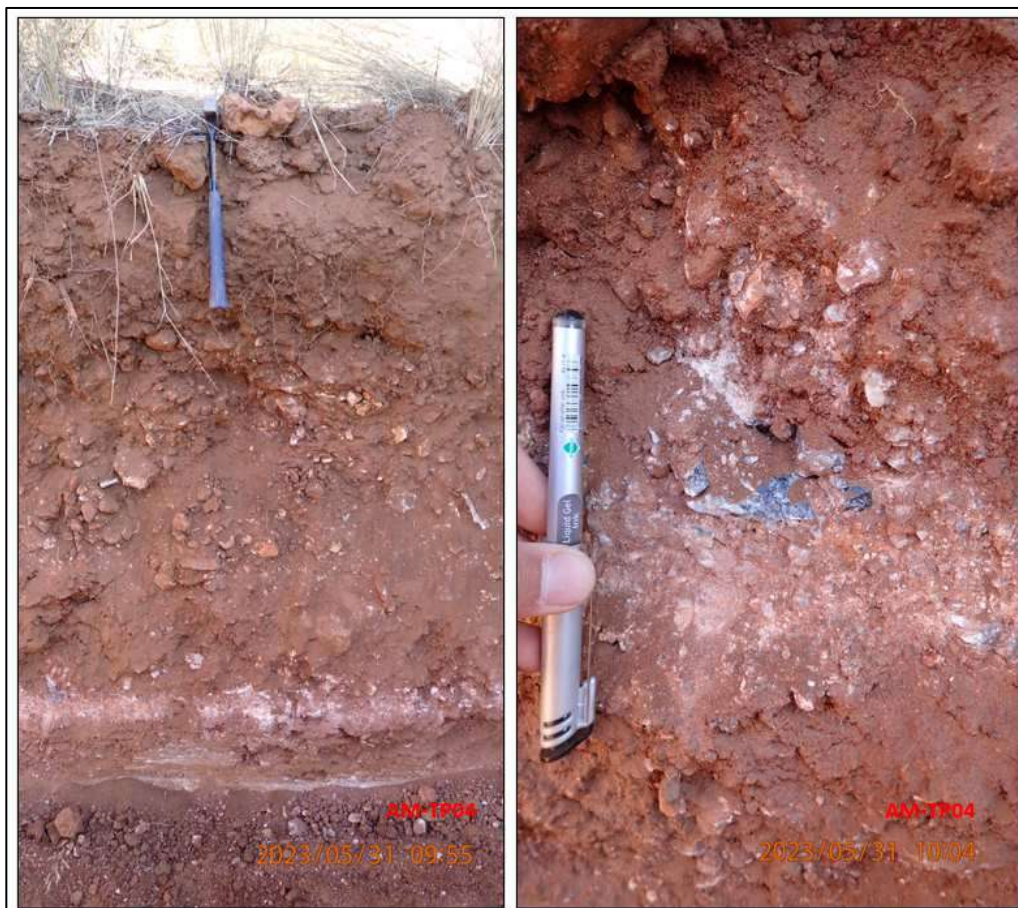
Plate 30: Typical profile west of the potential borrow area.
