# Traffic Impact Assessment Omitiomire Copper Project

**Submitted by:**  
**Zutari Namibia (Pty) Ltd.**  
Mandela Offices 1  
Windhoek, Namibia  
Project Number 1002938

Document Control	
Project	TIA of Omitiomire Copper Project
Project Number	1002938
Date	August 2023
Revision	0
Author	Anita Badenhorst
Reviewer	Watze Hepkema

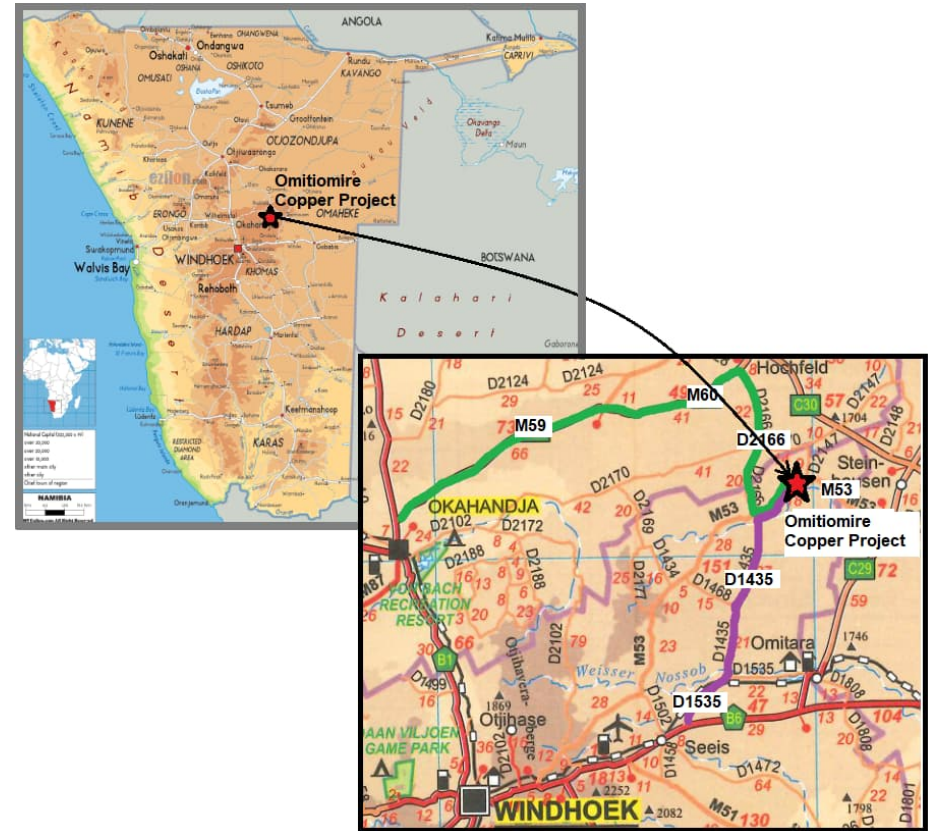
Figure 1: Locality Map – Omitiomire Mine

The Omitiomire Copper Project is proposed on the farm Groot Omitiomire located approximately 140km north-east of Windhoek in the Khomas region of Namibia – refer to the locality map in Figure 1. The project involves a small scale, stand-alone oxide mining and beneficiation operation to mine near-surface areas of weathered copper oxide.

- Access to the mine will be from Main Road 53 (MR53).
- Two possible transport routes have been identified. With reference to Figure 1, these include:
  - The green route along MR59, MR60, DR2166 and MR53 which has been identified as the shorter route to Walvis Bay; and
  - The purple route along DR1535, DR1435 and MR53 which carries much less traffic.
- The green route intersects with the B1 and the purple route with the B6.

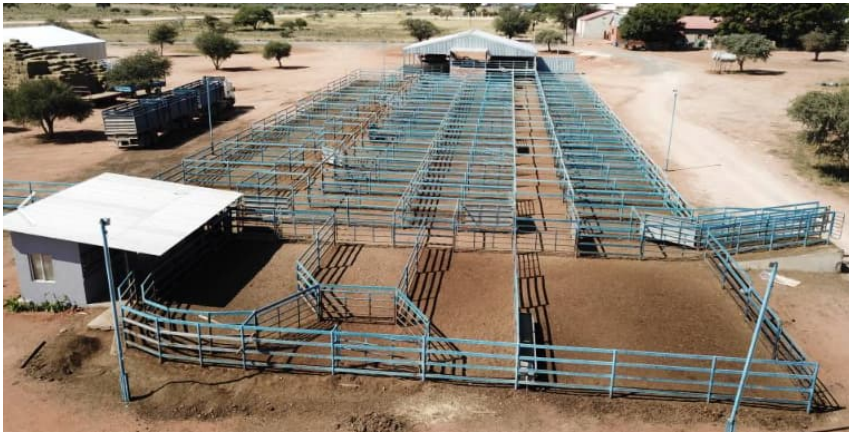
Figure 6: Aerial view of Hochfeld Auction Pens

One of the receptors to remark on is Hochfeld Livestock auction pens on Okajura farm. This receptor consists of homesteads, auction facilities, cattle pens and plantations under irrigation. The facility generates relative high volume traffic during auctions with a high percentage heavy vehicles making use of the roads surrounding this auction facility.

The Hochfeld Auction Facilities on MR60 consist of houses, barns, offices, cultivated fields under irrigation systems and holding pens. Some of the houses are located less than 200m from the center of the road while some of the irrigation systems is less than 100m from the road. Regular auctions are being held here accommodating hundreds of cattle standing in holding pens for a few days.

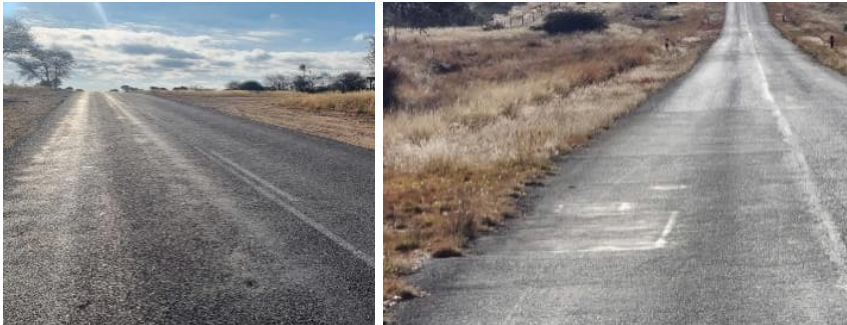
The first 20km of this road has a low volume sealed surfacing. Evidence of regular maintenance is visible.

Photos taken at km 1.2 and km 14.7 respectively, indicating the low volume seal pavement and some pothole repairs.

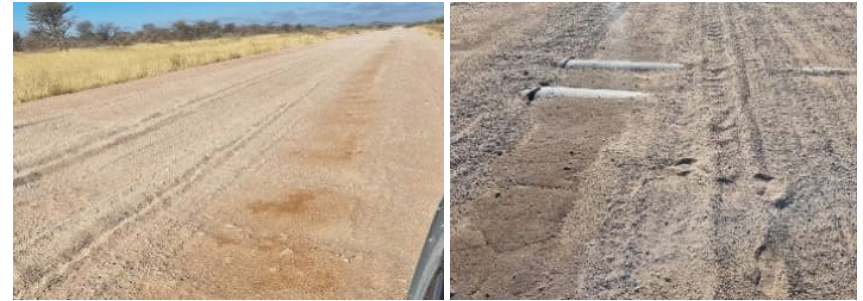
The gravel section, 44km, of MR59 has reached the end of its service live due to pavement failures. There are numerous potholes, exposed stormwater pipes, extreme rutting, exceptional dust, and no crown left.

Photos taken on km32 and km40 respectively indicating pavement failure.

The Roads Authority of Namibia plans to upgrade MR59 to bitumen standards in the next three years, budget restraints could prolong this period. This road has not been re-gravelled in the last 12 years and upgrading needs to be done as a matter of urgency. For MR59 and MR60, the upgrading actions recommended could be negotiated with the Roads Authority and other road users for example the Hochfeld Auction Pens owners as the current traffic volumes on these two roads warrant for upgrading and actions are planned for both these roads in the Roads Authority's maintenance plans.

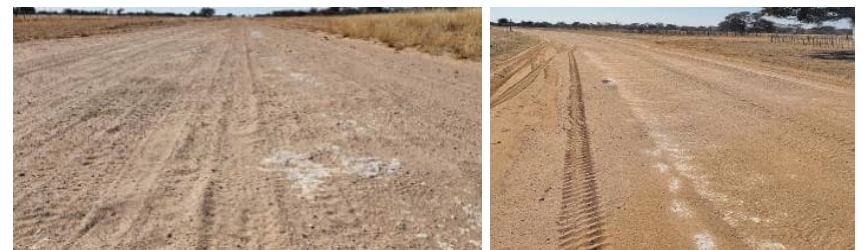
This gravel road of 41km, MR60, is failing on some sections. Corrugation, improper roadside drainage, and large potholes were encountered. Large sections of the MR60 are however still in a relatively good, rideable condition.

Photos taken on MR60 at km 17.5 and km 43 respectively indicating the road condition.

- It is suggested that MR60 be re-gravelled before the mine is fully operational. This road is equipped with stormwater structures and no upgrading to the geometric alignment is needed. Minimum actions to be taken will be spot re-gravelling on sections where the pavement has failed.
- The DR2166 is mainly an earth graded road, and the pavement is not expected to last under heavy traffic. It is recommended that DR2166 be gravelled before the mine is fully operational to ensure the road is maintained in an accessible condition. This road is not equipped with stormwater structures and culverts will need to be constructed at critical places.
- MR53 need to be gravelled as it is not expected to withstand heavy traffic. This road is not equipped with stormwater structures and culverts will need to be constructed at critical places.

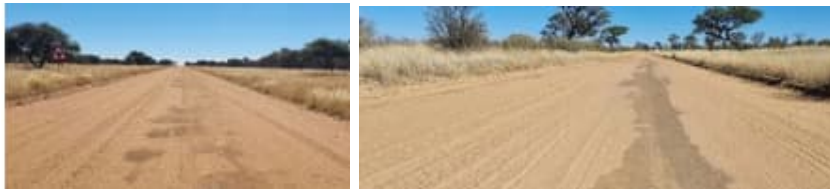
graded, no roadside drainage is present. Most sections however do seem to have a high PI, which was also confirmed with the material test results received. A high PI assist in reducing dust generation, corrugation and help prevent potholes forming. The downside is the road might become slippery when wet and once the pavement starts to fail, the deterioration is swift.

Photos taken on km 21, DR 2166 and km 10.7, MR 53, respectively, indicating the road condition.

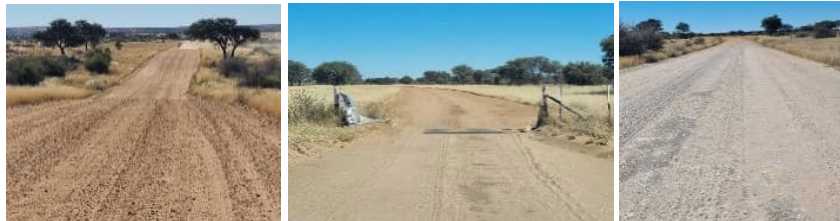
Most of DR1435 is earth graded with isolated gravelled sections. The pavement is in a good rideable condition with minor failures. No drainage structures have been recorded and some water course crossings need to be upgraded. Two cattle grids, at different locations, pose width restrictions and potential safety hazards. The road crosses a railway near the intersection with DR1535.

Photos: km 14.5, km 34 and km 34.4 indicating a water course crossing, cattle grid and isolated gravelled sections.

- DR1435 will be able to withstand the initial construction traffic but as this road is largely an earth graded road, the pavement is not expected to last under heavy traffic. It is recommended that D1435 be gravelled prior to the mine going into full operation to ensure the road remains in an accessible condition. This road is not equipped with stormwater structures and culverts will need to be constructed at critical places. The road has various sharp horizontal curves and some geometrical improvements should be considered to reduce the road safety risks.

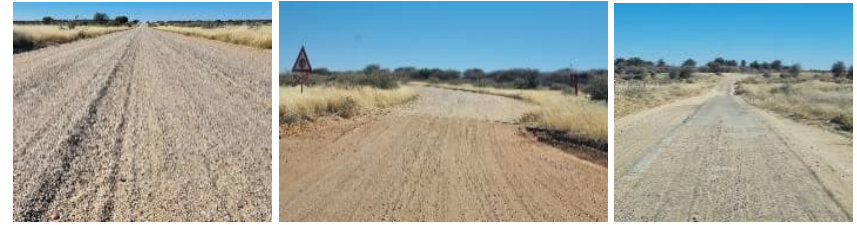
DR1535 is a gravelled road in a good condition. Only minor failures have been recorded. No drainage structures have been recorded except for a single lane, 150m long, concrete drift through a river crossing. The road crosses a railway at two separate locations.

Photos: km 6.8, km 13.8 and km 18.1 indicating minor failures, a rail crossing and a concrete drift.

- DR1535 is in a good condition, and it is expected that the road could withstand the additional heavy traffic for the first few years. The road, or sections thereof, will need to be re-gravelled before the mine is fully operational. The only stormwater structure is a single lane concrete drift. This drift should be upgraded to a culvert crossing to ensure all year access to the mine. Culverts should be constructed at critical places.

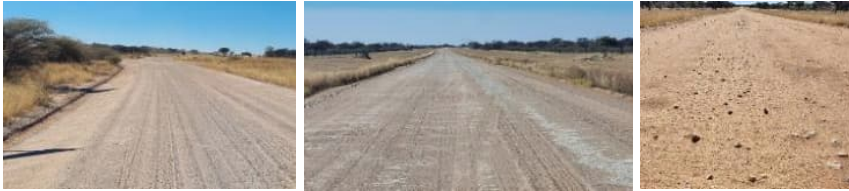
The material test result received from the sample taken on MR59 indicates that this material is suitable for a wearing course, the structural top layer in a gravelled road. As this sample was taken on the edge of the road and the layer has been constructed more than 10 years ago, there are a good possibility to obtain G5 material in the vicinity. G5 material could be used for the supporting layer in a bituminous sealed road.

The material samples taken on DR2166 and MR53 consists mostly of sand with little to no gravel present. The high PI content provided for good rideability and little corrugation. The in-situ material seems to be suitable for a SSG layer, the supporting layer in a gravelled road.

Photos taken on MR59, MR60 and DR2166 respectively, indicating material on sections of these roads.

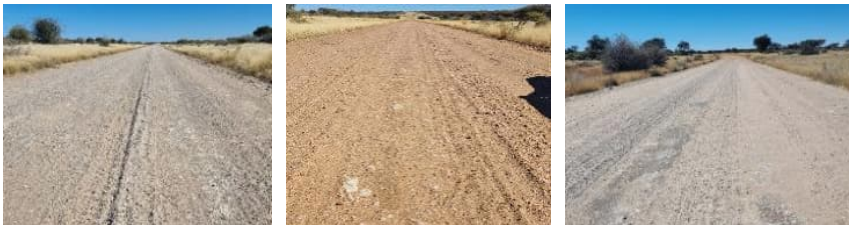
The material result received on the test taken on DR1435 meets a SSG layer standard. The result of the test taken on the short, gravelled section, also meets a SSG standard. The only limit not meeting the subbase course standard, is the Grading Modulus. Wearing course material, which is mostly the same as subbase material, except for a higher “clay” content, could be expected to be available in the vicinity if this road needs to be upgraded to a gravelled road.

For the material test result received from DR1535, the limits meet a subbase standard except for the Grading Modulus of 1.43, which needs to be 1.5. The result correlates with the visual observation of the pavement structure. It could be expected to find wearing course material on the road and in the vicinity.

Photos taken on DR1535, DR1435 and DR1435 (gravelled section) respectively, indicating material on sections of these roads.

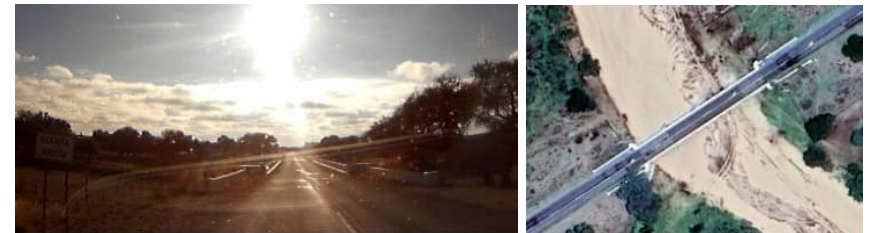
Three significant streams cross the sealed section of MR59 at km 2.8, km 7.1 and the Swakop River at km 10. The crossing at km 2.8 consists of a 55m long bridge structure with a road width of 5.4m wide, suitable for two-way light traffic. The narrow bridge width will be a road safety risk for two heavy vehicles crossing simulations. The stream crossing at km 7.1 is a sealed concrete drift, crossing the 16m wide stream. The Swakop River at km 10 is 40m wide and is crossed with a sealed concrete drift.

Photos at km 2.8, MR 59, stormwater structure: 5.8m wide

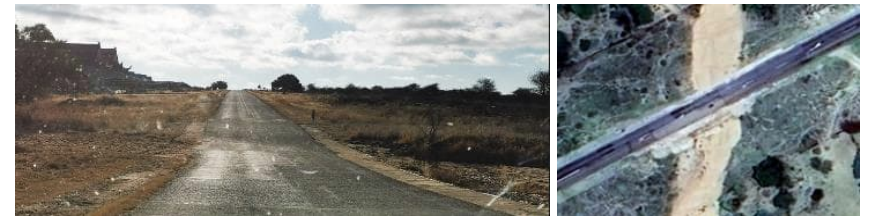
Photos at km 7.1, MR 59, sealed concrete drift

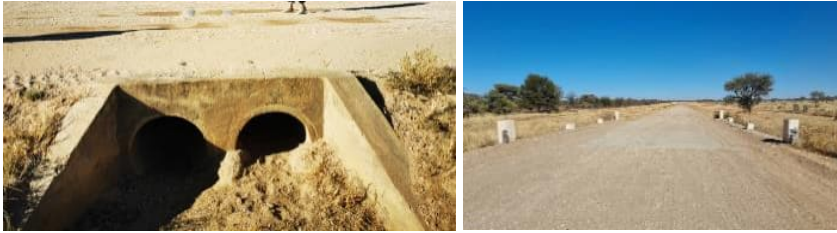
The gravel section of the route, running along MR59 and MR60, is fitted with stormwater structures such as small bridges and culverts. These sections are relatively flat and little to no upgrading to the vertical alignment is expected.

Photos of stormwater structures on km 42.8, MR 59 and km 12.4, MR60.

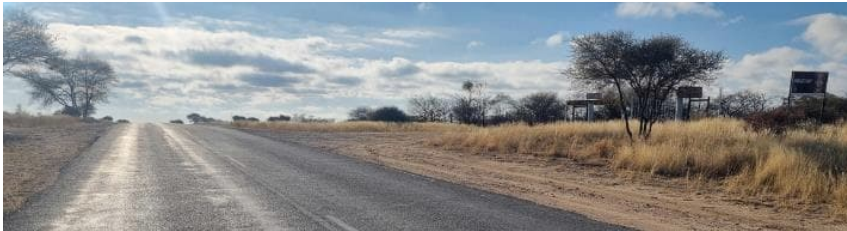
A few entrances were noted to be positioned on crests or curves. If the road is upgraded, travel speed will increase, and the sight distances should be evaluated. Upgrading to entrances might be needed if the sight distance is insufficient. Insufficient site distance might pose a safety hazard.

Photo of entrance to Ombo Rest Camp, km1.2 on MR59

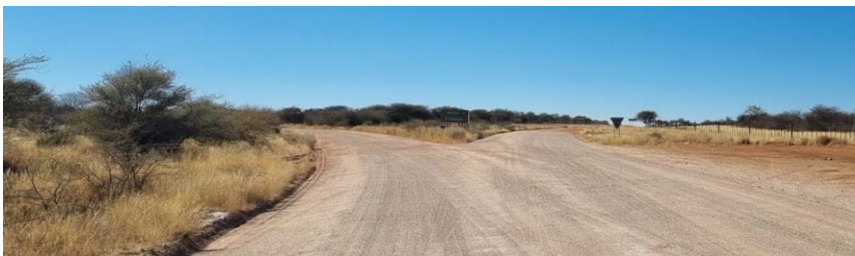
The intersection between MR59 and MR60 need to be redesigned and reconstructed. Currently this intersection is a Y-intersection and a major safety hazard for traffic traveling on MR59 onwards on MR60. The issue is the intersection angle which restrict sight visibility and poor guidance to the priority of traffic.

Photo of intersection MR59/MR60

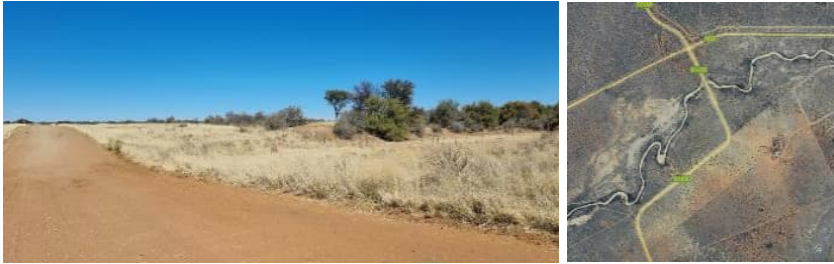
Photos of water course crossing on DR1435 at km 48.6

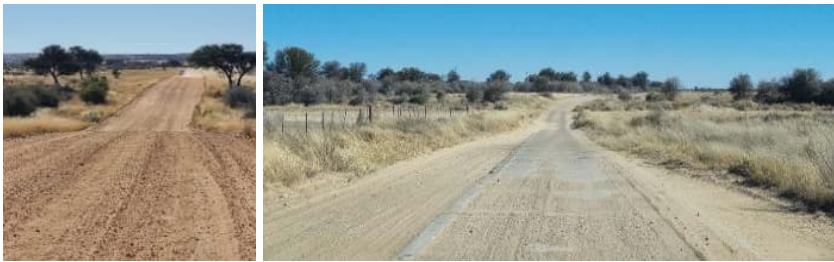
Photos of water course crossing on DR1435 at km 14.5 and concrete drift on DR1535, km 18.9

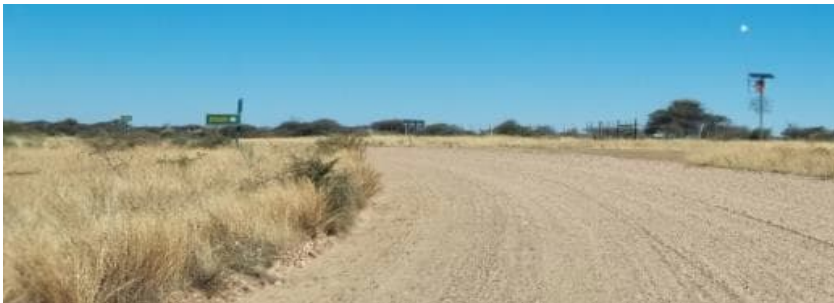
Intersection of DR1435 and DR1468 at km 22 on DR1435 is situated on a curve. This poses as a safety hazard, especially if this road is upgraded and traveling speed increases. Sight distance is limited and should be evaluated in more detail.

Photo of intersection DR1435/DR1468

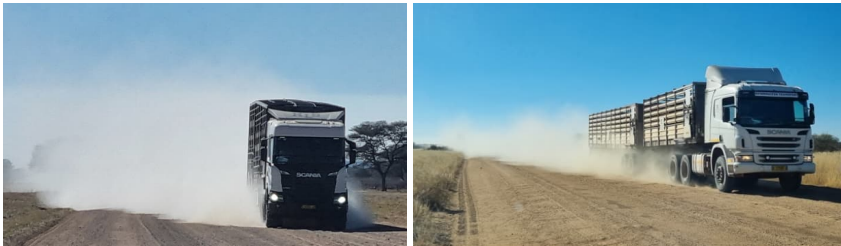
One major and obvious problem associated with all unpaved roads is dust. To residents living along unpaved roads the airborne dust can penetrate their homes causing a nuisance and health problems such as hay fevers and allergies.

Photos taken on MR53 of dust generated by heavy vehicles.

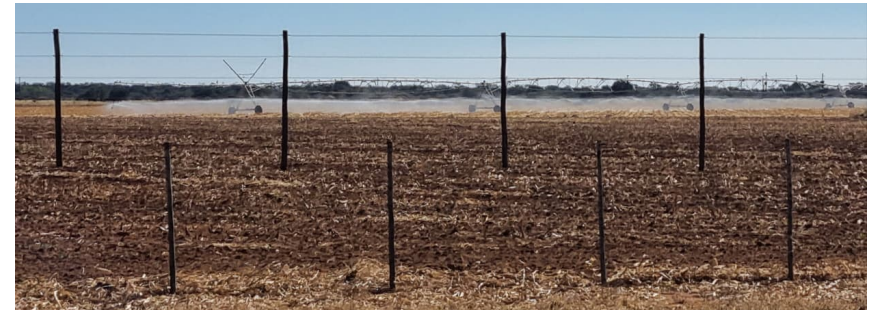
Photo of cultivated field under irrigation system on MR60.

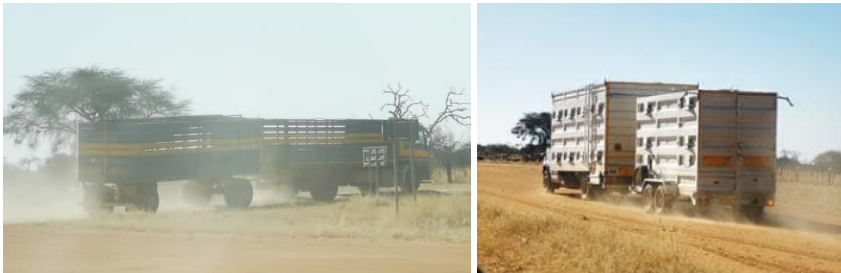
Photos taken on MR60 and DR2166 of typical heavy vehicles currently travelling on these roads.

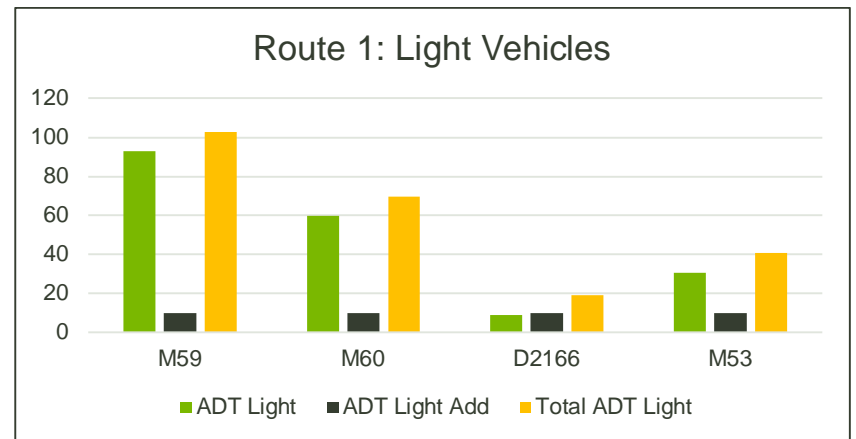
To illustrate the impact of the additional traffic on receptors along the routes, the following graphs were developed. These graphs show the current traffic, generated traffic and the total traffic on each road section.

**Figure 13: Impact of generated light traffic on Route1**

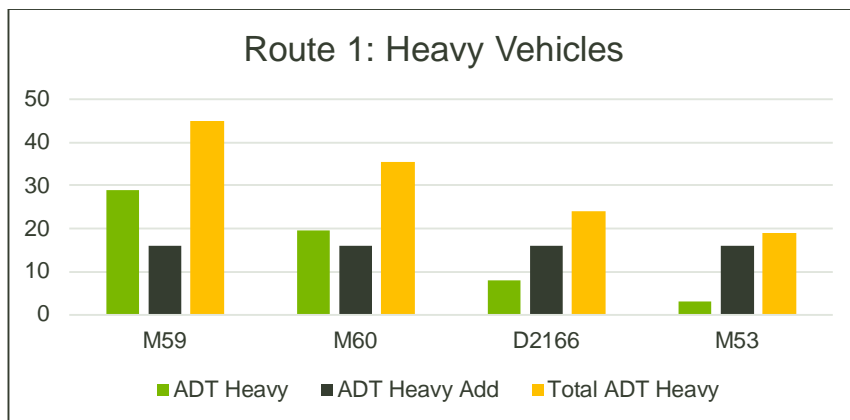
Figure 15: Impact of generated heavy traffic on Route 1

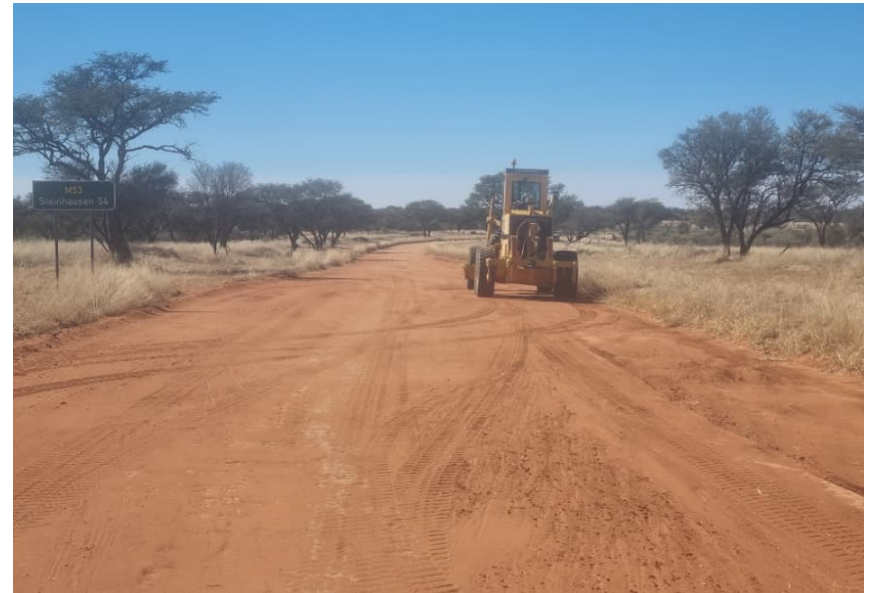
Good gravel road maintenance depends on two basic principles: proper use of a grader and the use of good surface gravel to gravel or re-gravel the road. It is further most important to keep water drained away from the roadway. Standing water at any place within the cross section is one of the major reasons for distress and failure of a gravel road. The effect of heavy vehicles on these roads are significant. Regular maintenance is therefore of paramount importance. Road maintenance are divided into routine maintenance and periodic maintenance. Routine maintenance are non-structural in nature and are meant to extend the life of the road pavement. Periodic maintenance is to maintain the structural condition of the road.

Foto of Routine Maintenance on MR53
